## CASE STUDY OF EXISTING BUILDING CLADDING LESSONS LEARNED

**James A. Bychowski, PE, BS FPE, MBA**

Kuwait Conference

Wednesday, December 06, 2017, Crowne Plaza Kuwait

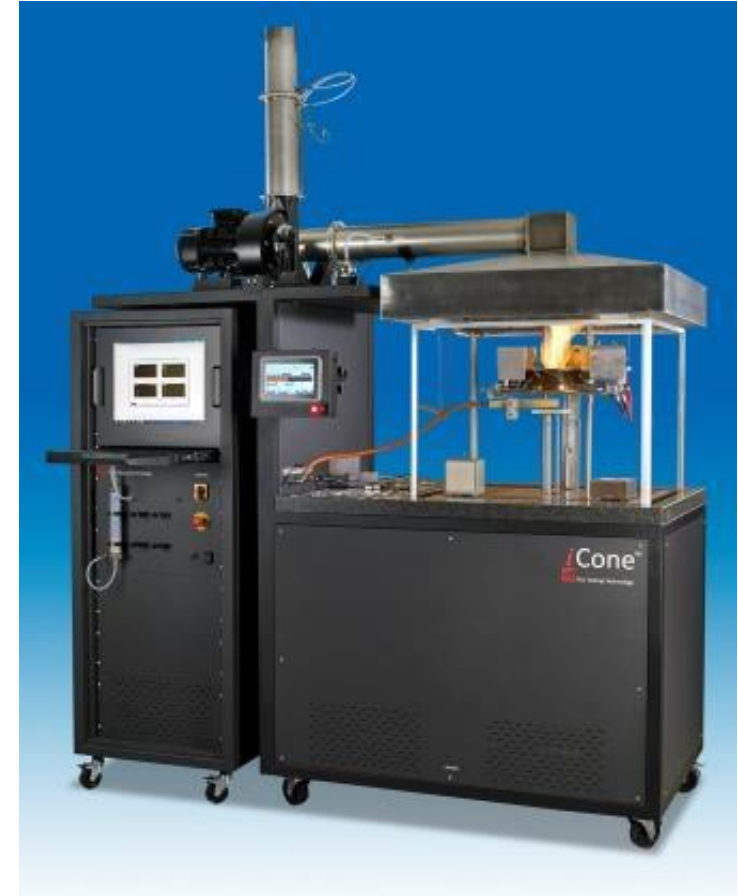
## ASTM E1354 – CONE CALORIMETER TEST

- Sample size = 10cm X 10cm
- Samples were subjected to incident heat flux exposures of 35 kW/m<sup>2</sup> and 50 kW/m<sup>2</sup>
- Duplicate and triplicate tests were run to obtain reliable data

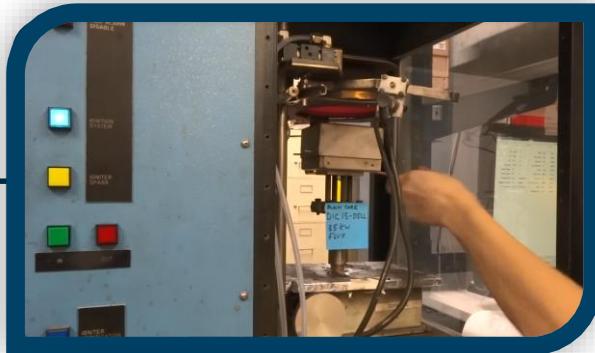
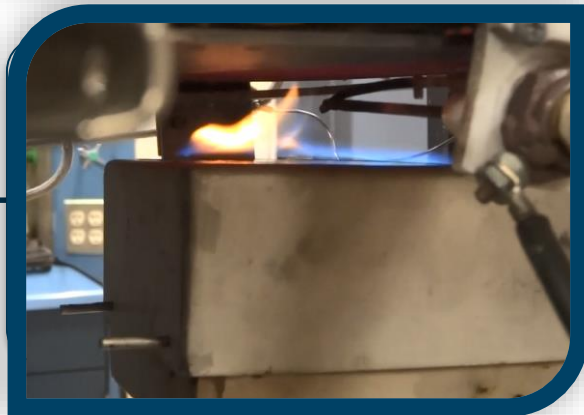
Samples subject to heat flux exposure of 50Kw/m<sup>2</sup>

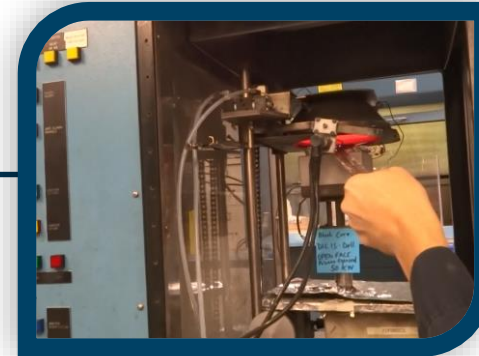
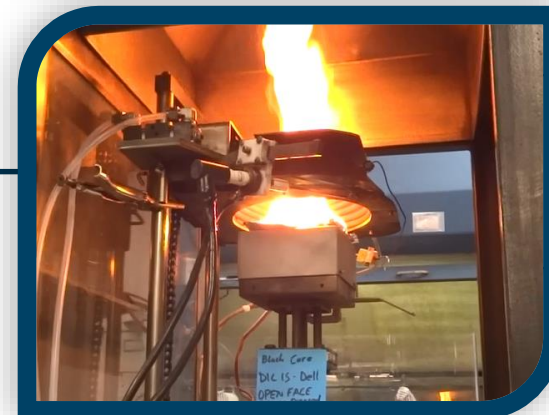
Samples subject to heat flux exposure of 35Kw/m<sup>2</sup>

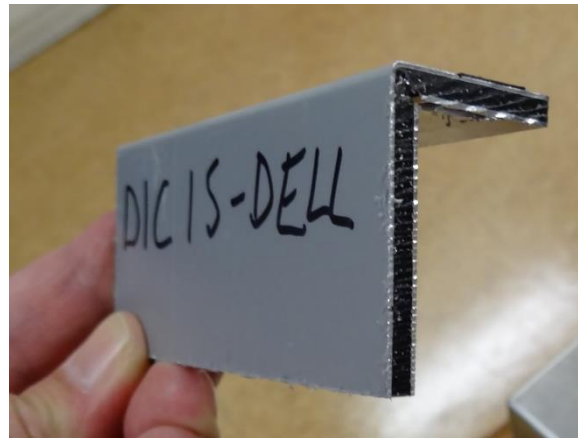
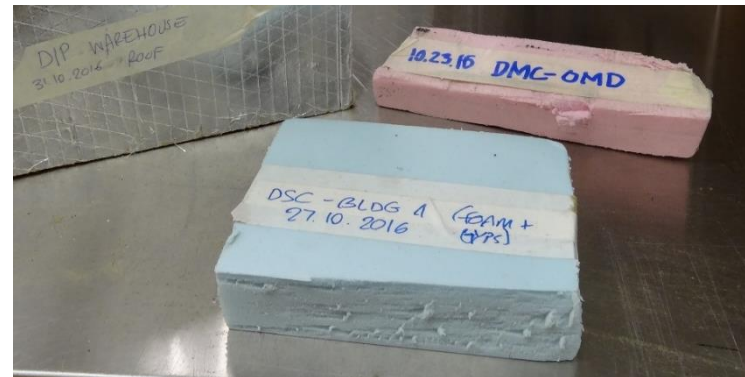
# TEST GROUPS

Three basic groups of panels:

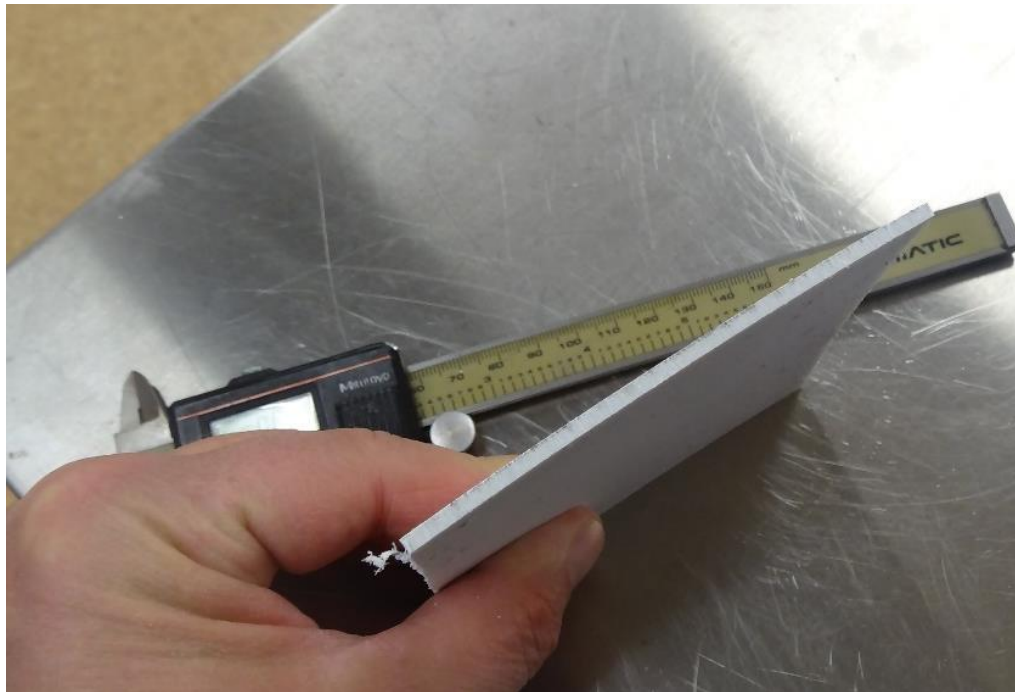
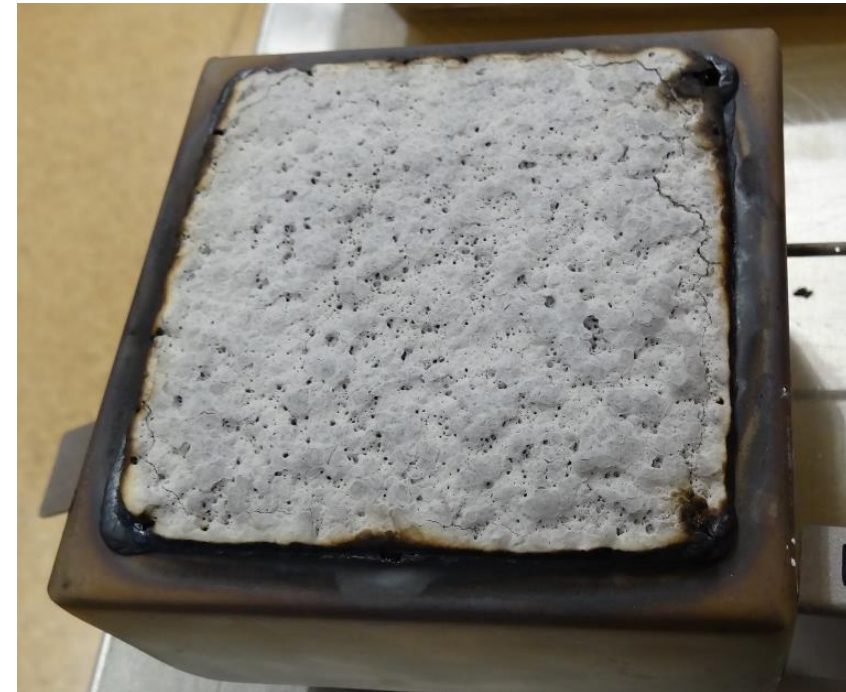
## GROUP 1A - WHITE CORE SAMPLES

- ACPs with white core material had peak heat release rates of 217 -229 kW/m<sup>2</sup>.

- GROUP 1A panels with white core with high heat release rates.
- GROUP 3 extruded or expanded foam plastic insulation installed behind a metal or ACP.
- JENSEN HUGHES' experience with large scale NFPA 285 testing shows that this type of construction (ACP panels over extruded or expanded foam plastic) exhibits unacceptable performance and fire spread on exterior walls.

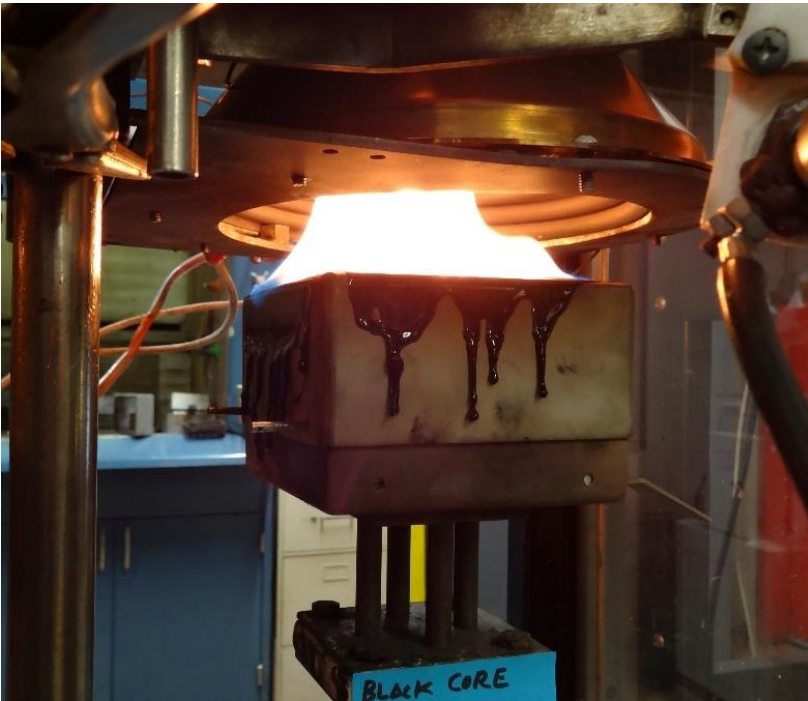
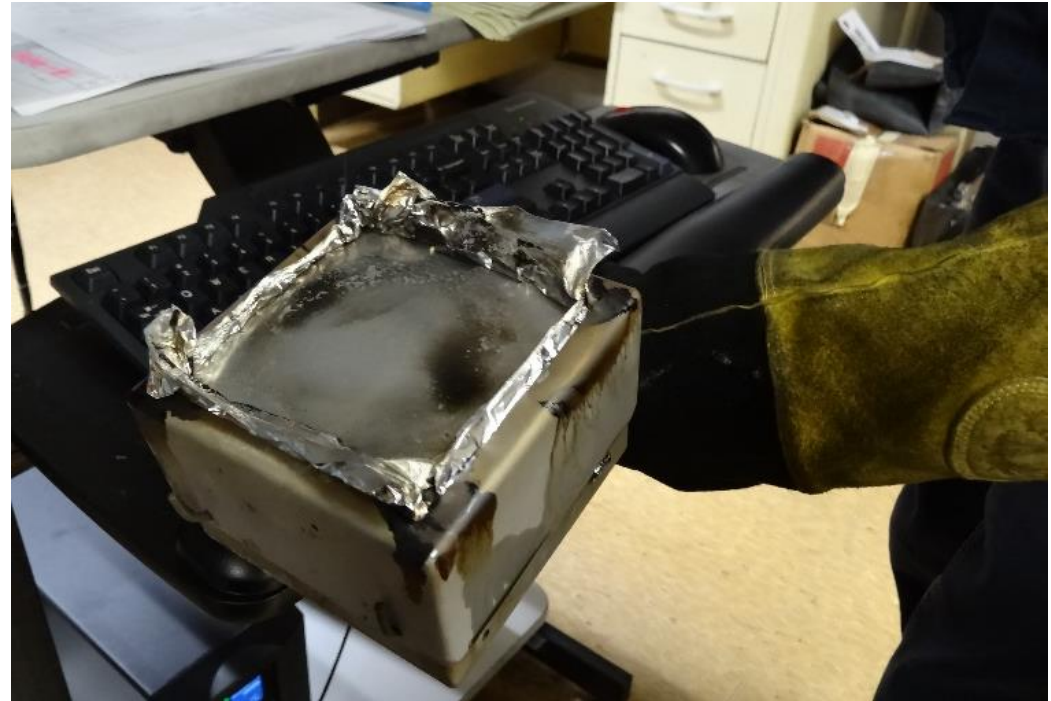
## GROUP 1B - BLACK CORE SAMPLES

- Black core samples had very high peak heat release rates of 600 to over 1000kW/m<sup>2</sup> with the core material exposed.

- Very high peak heat release rates
- Black core melts readily and FLOWS LIKE LIQUID.
- REPLACE all ACP panels with black core material or conduct DETAILED RISK ANALYSIS.

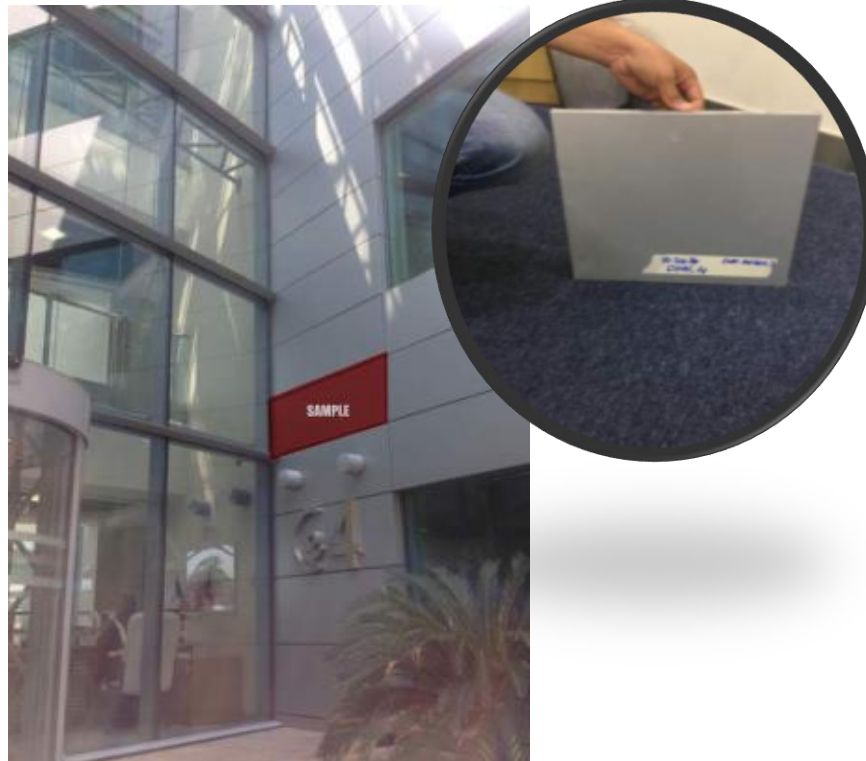
## GROUP 2 – METAL PANELS WITH NO BACKING MATERIALS

- No cone calorimeter testing was performed
- These panels were solely metal panels rather than sandwich panels with an integral combustible core.

- GROUP 2 metal panels with no combustible materials installed in the interstitial space behind panels.

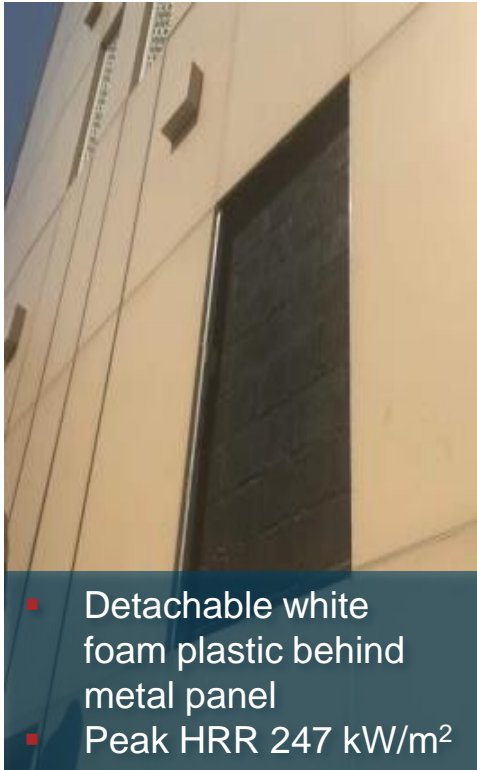
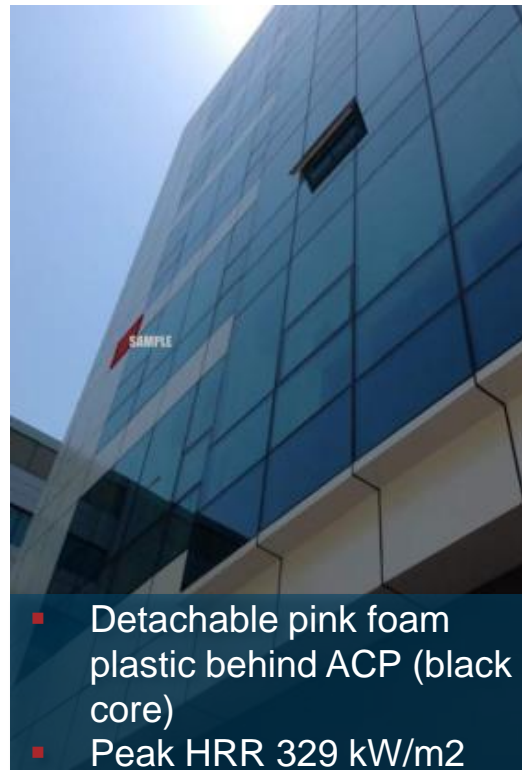
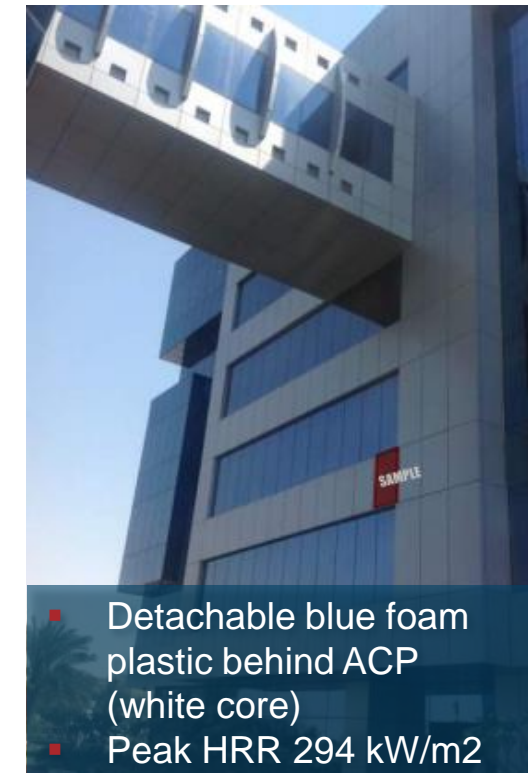
## GROUP 3 – METAL PANELS OR ACP WITH DETACHABLE EXTRUDED FOAM PLASTIC BACKING PANELS

- Peak HRR noted for the foam plastic
